**ROOFING - AN INVESTIGATION, AND RECOMMENDATIONS  
FOR IMPROVING PERFORMANCE ON  
ALBERTA GOVERNMENT BUILDINGS**

Department of Public Works  
Government of the Province of Alberta  
August, 1967.

RE: Roofing

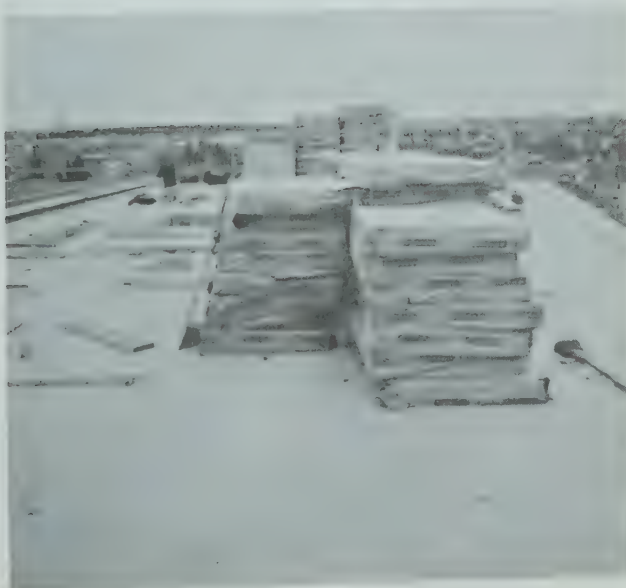
3A Improper storage of insulation.

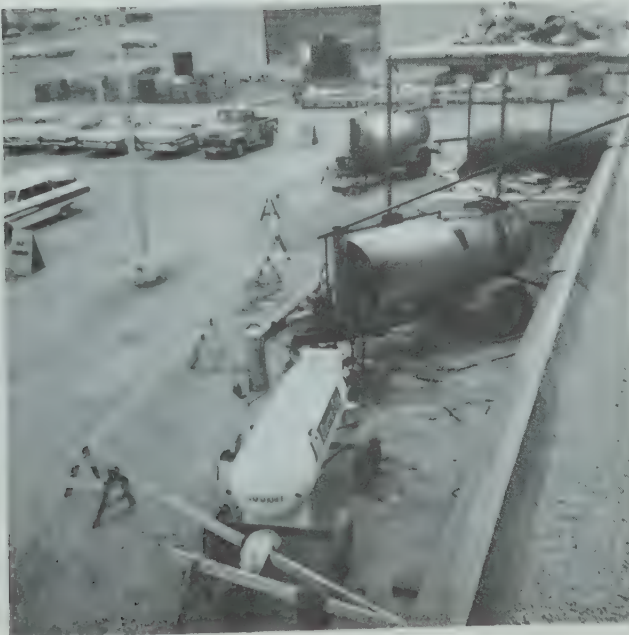
5. Preferable method of supplying asphalt to the work area - tank has circulating pump with bypass valve controlled by pull rope.

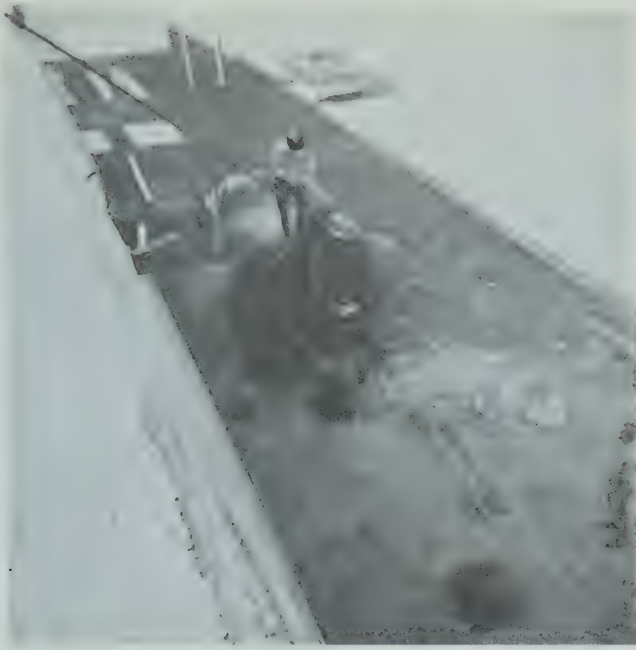
6. Preferable method of supplying asphalt to the work area.

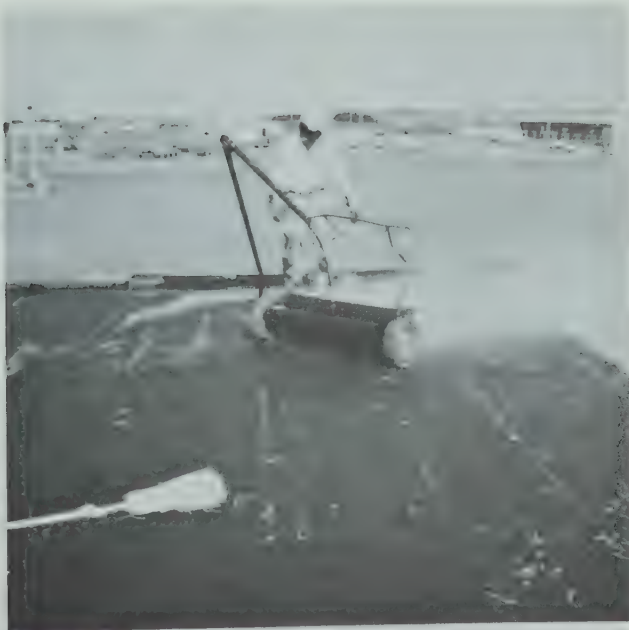
7. Asphalt being discharged directly into applicator.

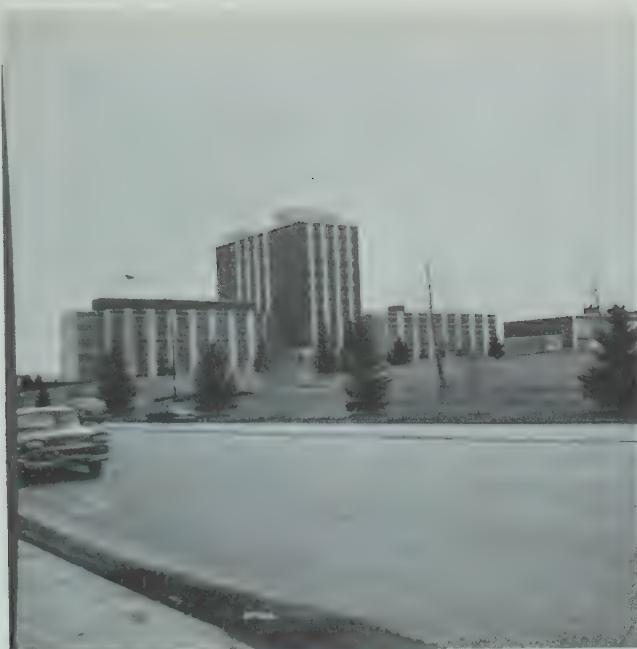
10. Low roof adjacent to tower.

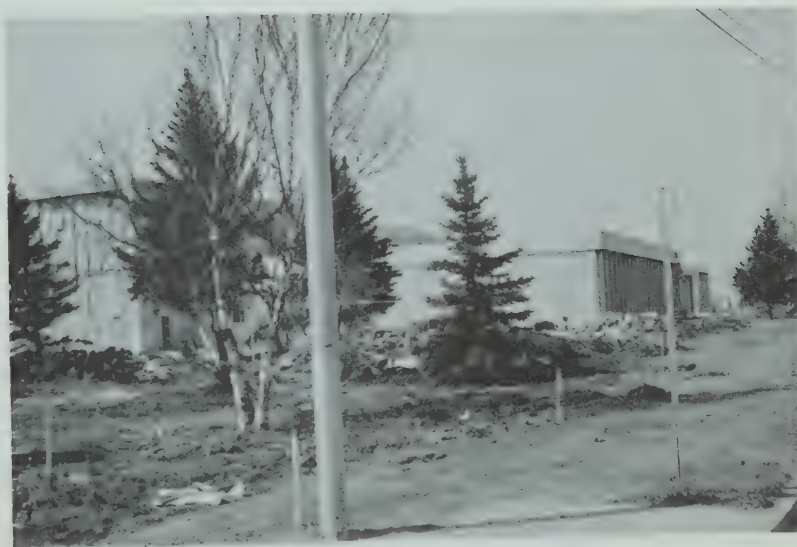
11. Low roof adjacent to high part of building.

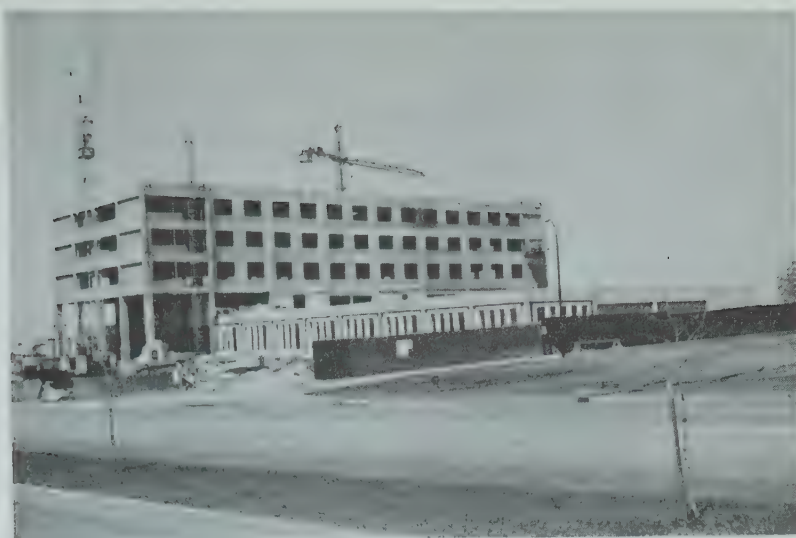
12. Low roof adjacent to tower.

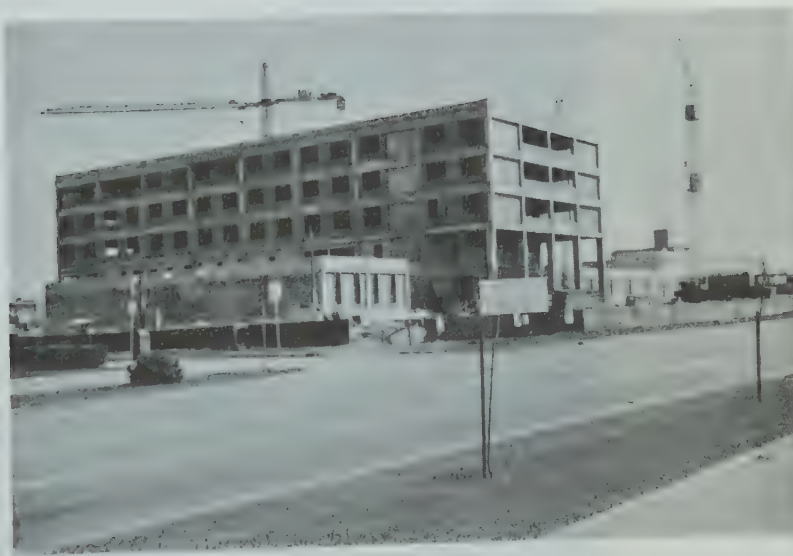
13. Low roof adjacent to tower.

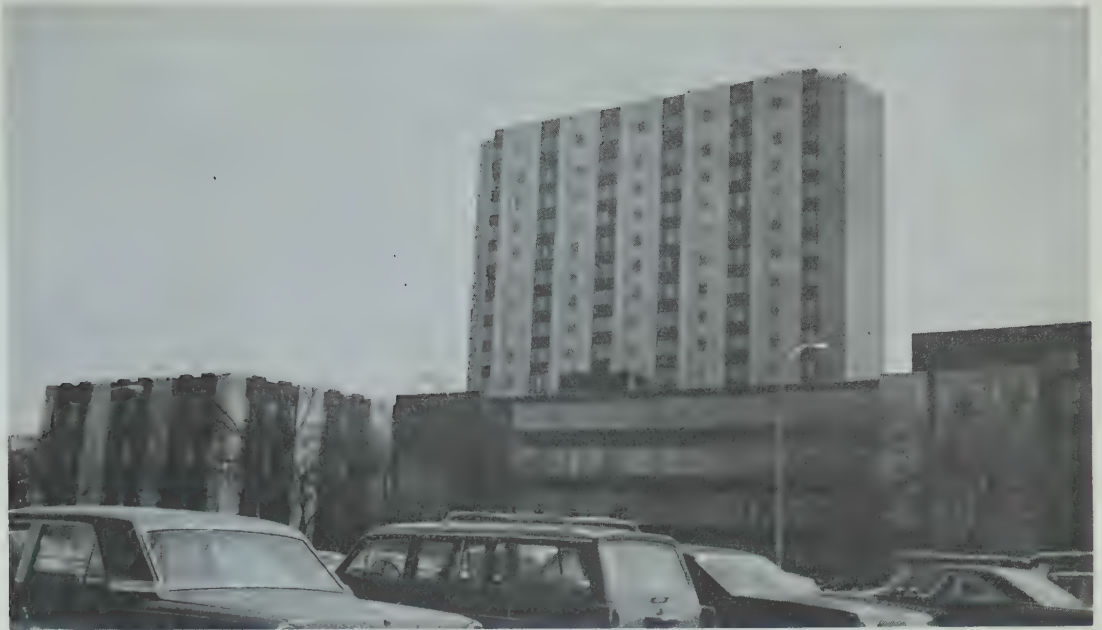
14. Low roof adjacent to tower.

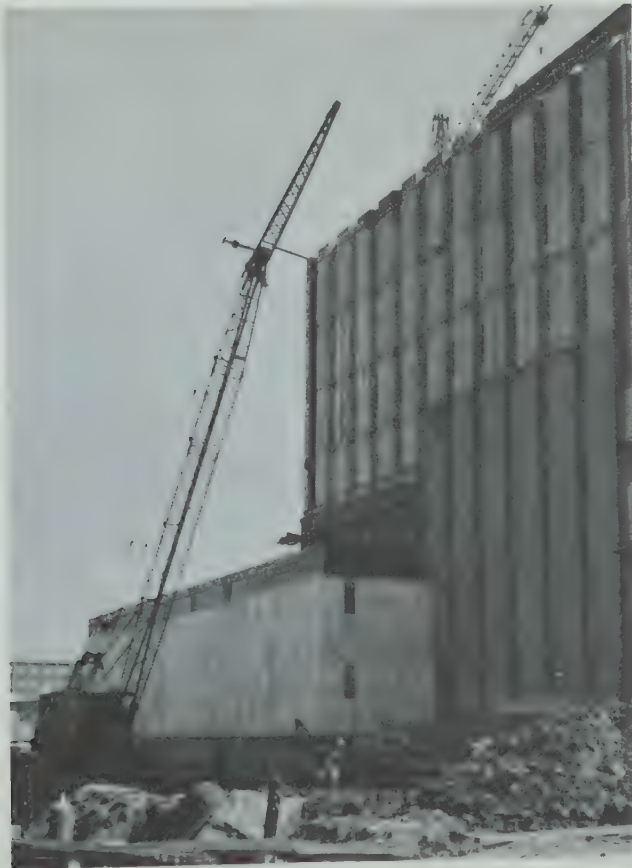
15. Low roof adjacent to tower.

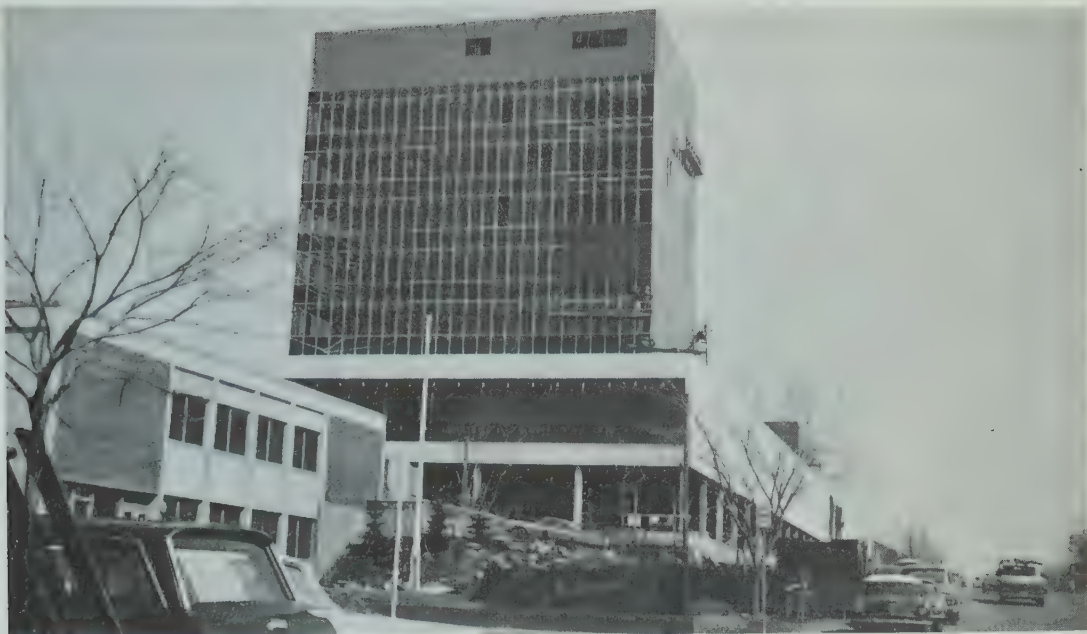
16. Low roof adjacent to tower.

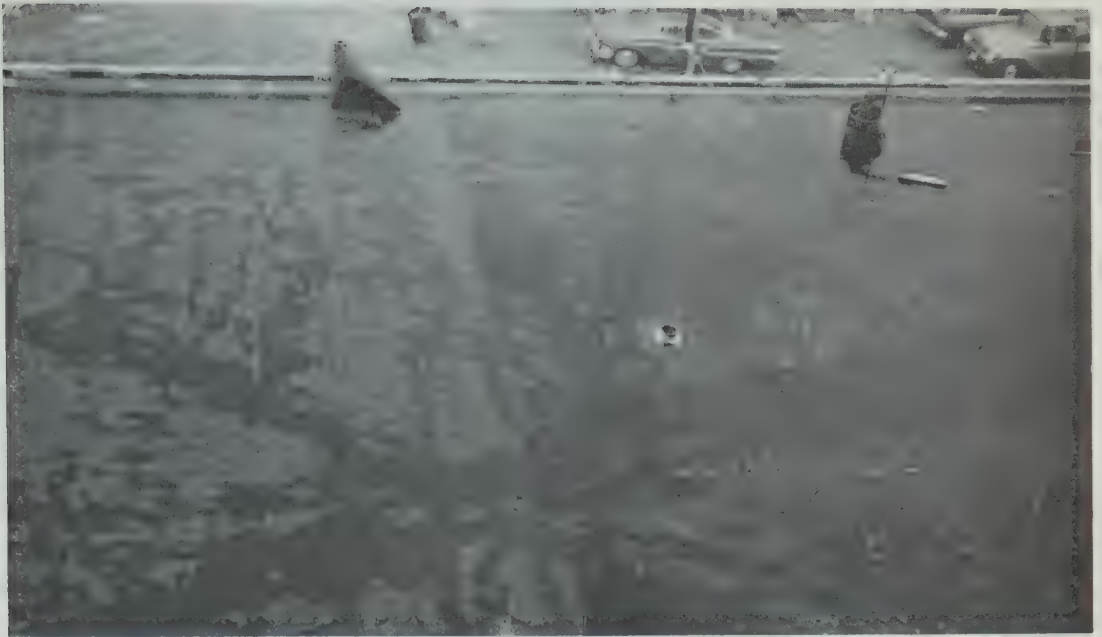
20. Sudden rainstorm - no chance to protect felts from getting wet.

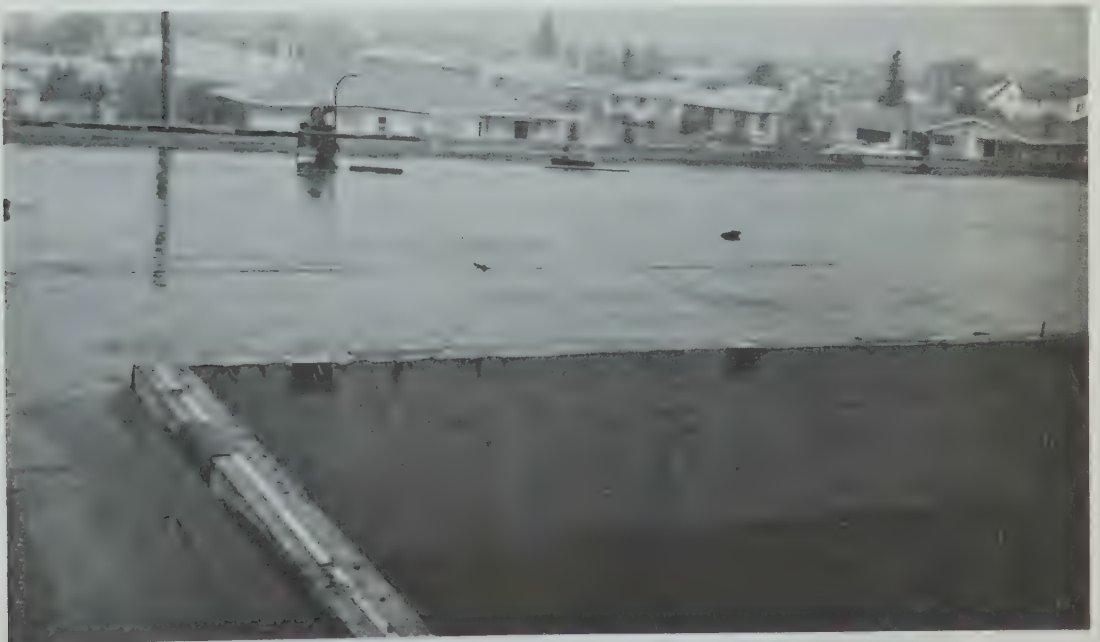
21. Fibre cant strips mopped when wet - note frothy asphalt lower lefthand corner.

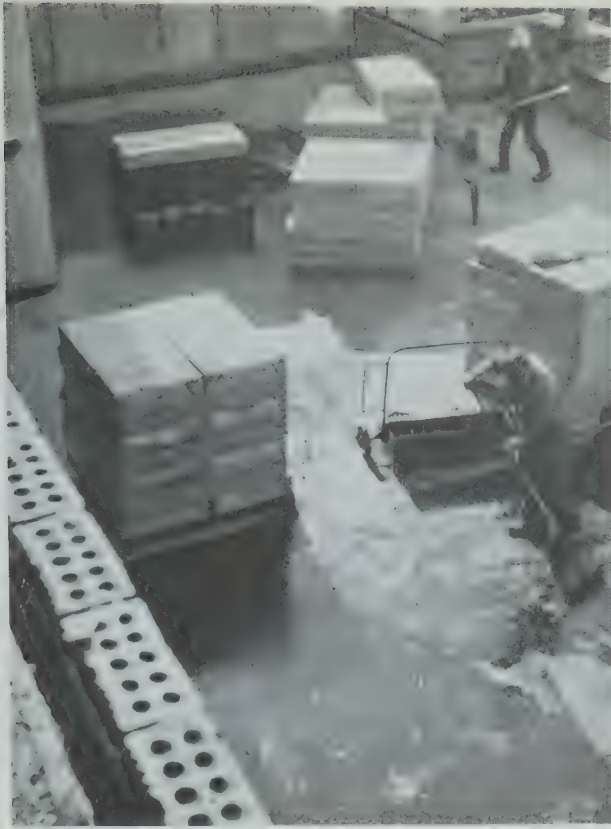
22. Proper palletizing of materials, however, note primer being applied over wet area of concrete deck.

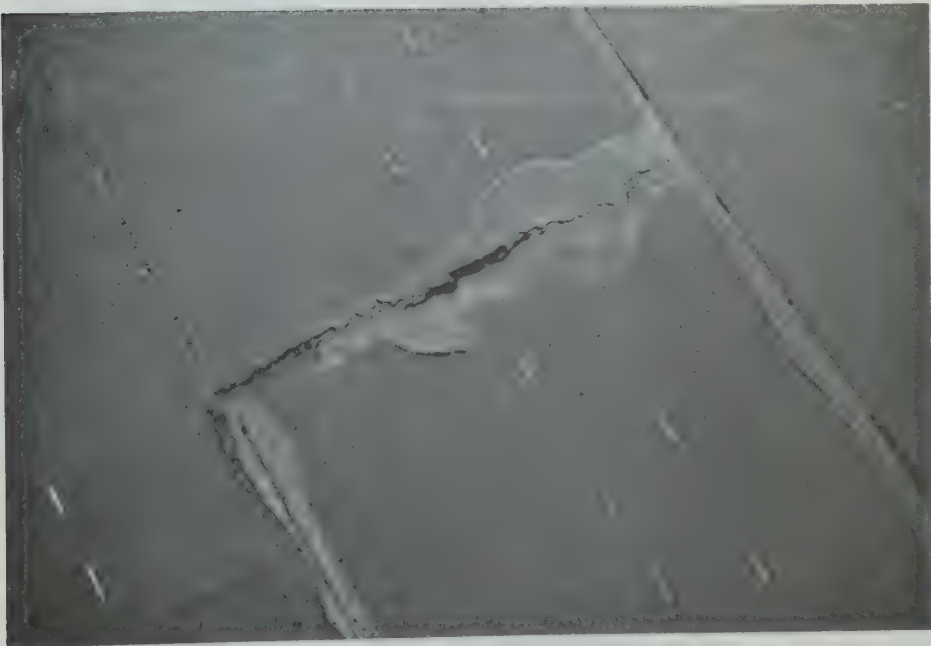
23. Split felt - should have been lifted and lapped properly.

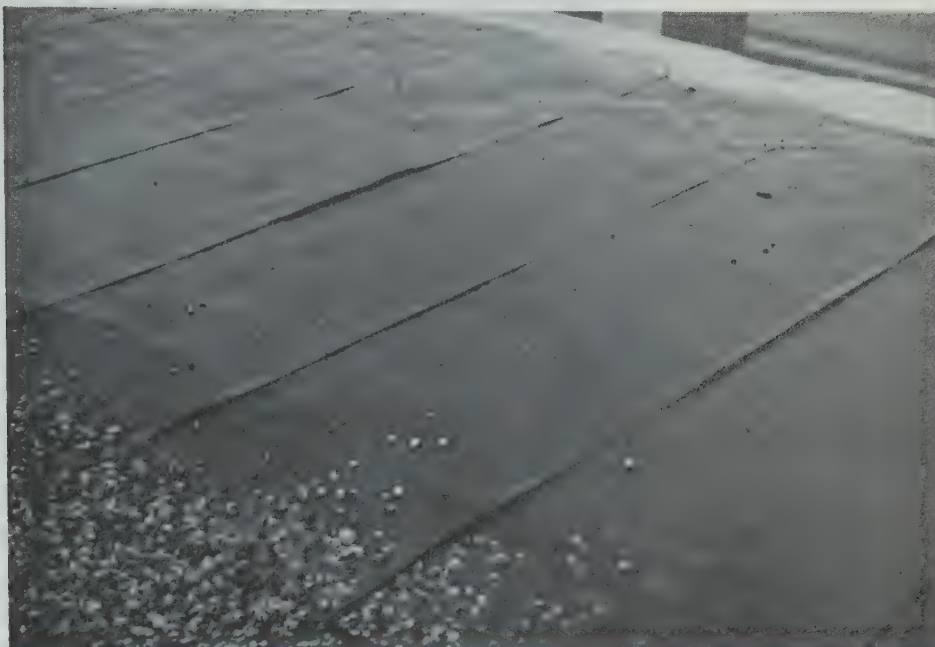
24. Fishmouthing - results from poor roll or poor rolling.

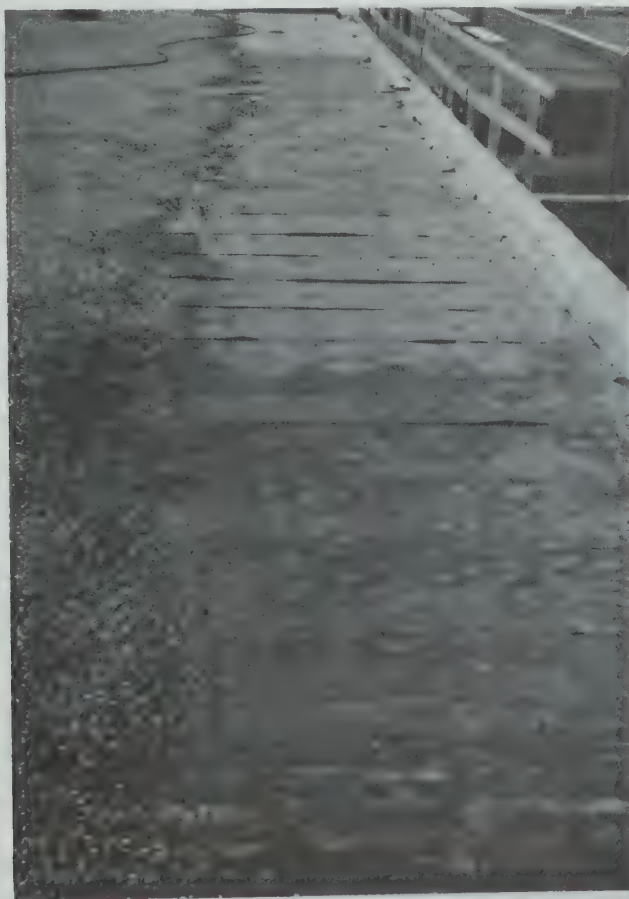
25. Fishmouthing and curled edges - unprotected felts.

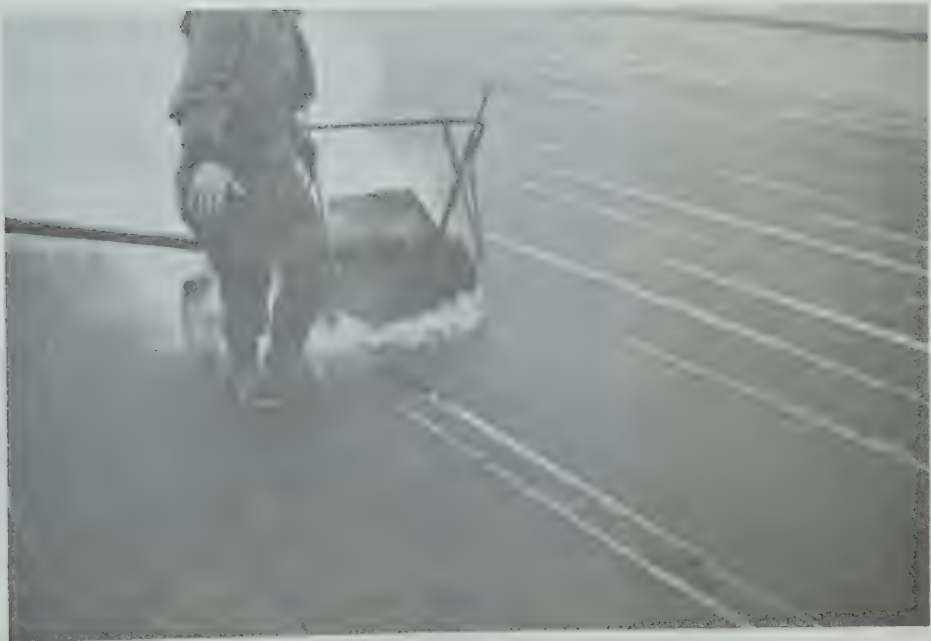
27. Application of hot asphalt using mechanical applicator (mini-mopper).

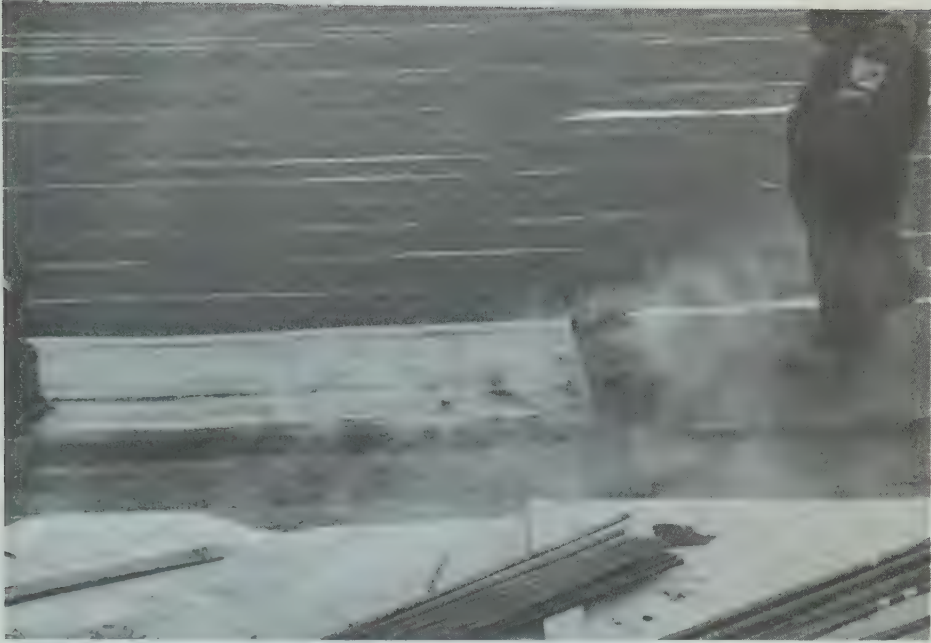
28. Rolling out the felt - kicking not recommended. Note puddle running ahead of roll - this puddle lessens considerably as roll lessens in weight.

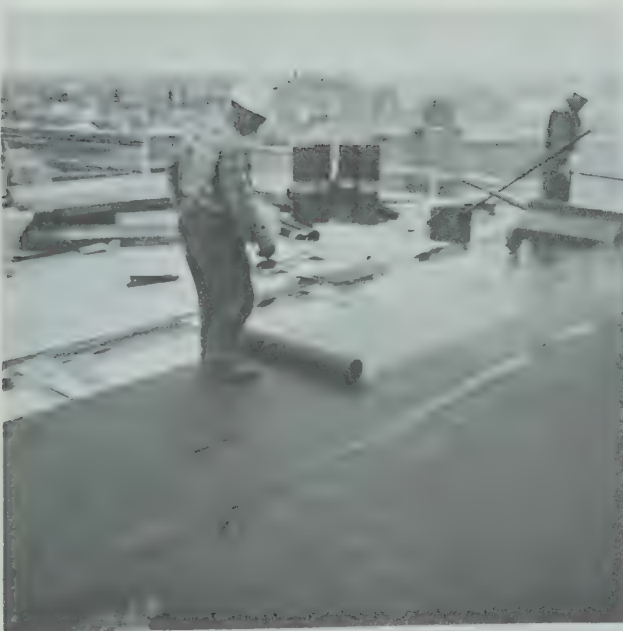
29. Toward end of roll - no puddle.

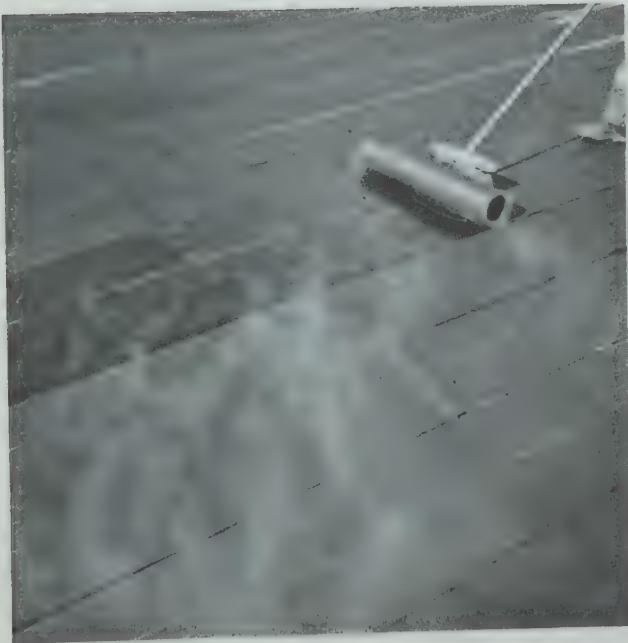
33. Proper rolling procedure - note puddle running ahead of roll, and use of broom. This membrane is being installed 2 + 2.

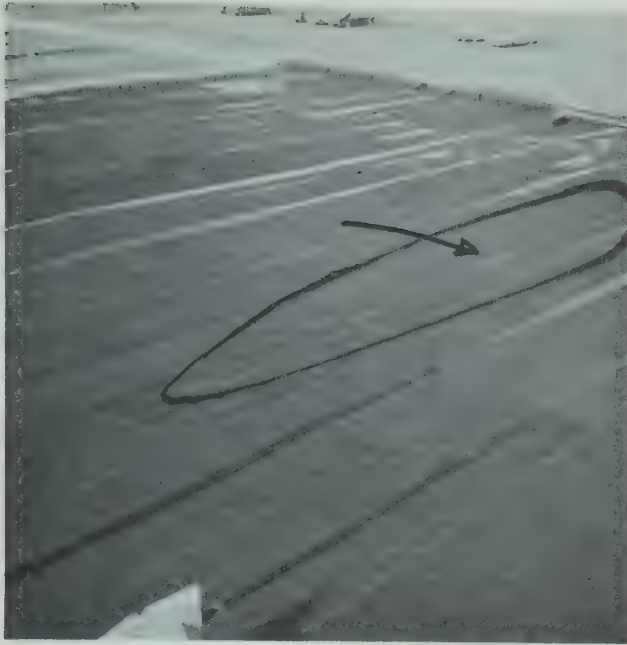
34. Over-saturated felts - note sheen on surface. Roll was difficult to keep straight.

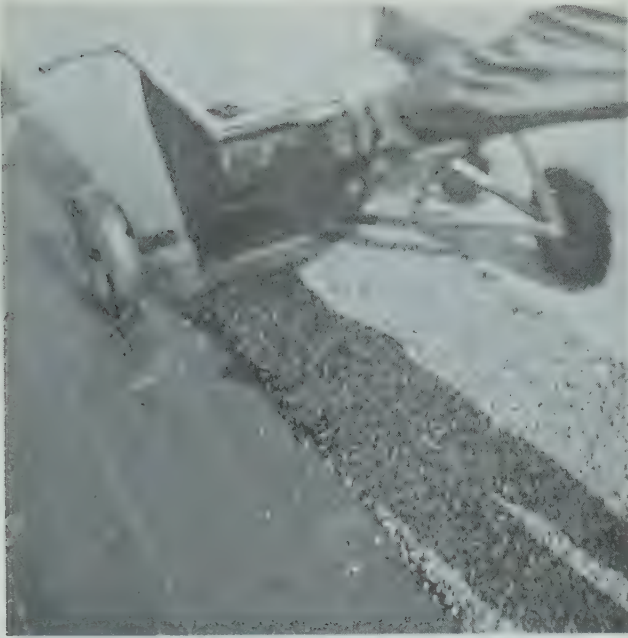
36. Uniform application of gravel through use of mechanical gravel spreader.

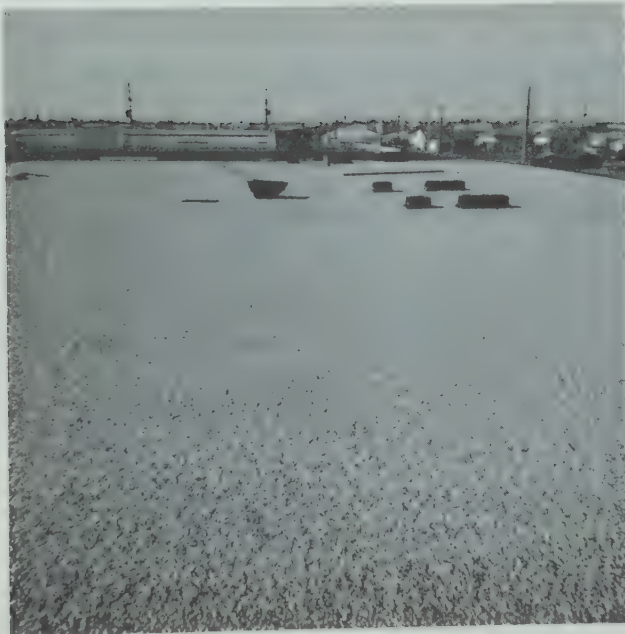
37. Roof gravelled using spreader.

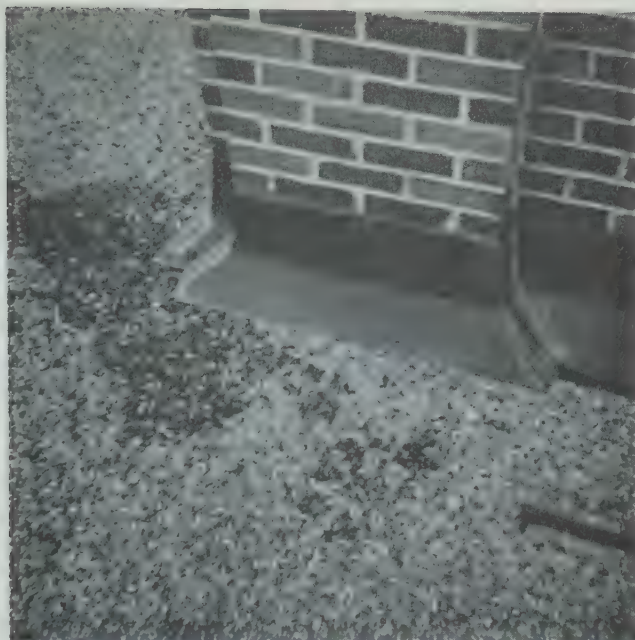
38. Gravel blown from membrane - asphalt left exposed to the sun and precipitation.

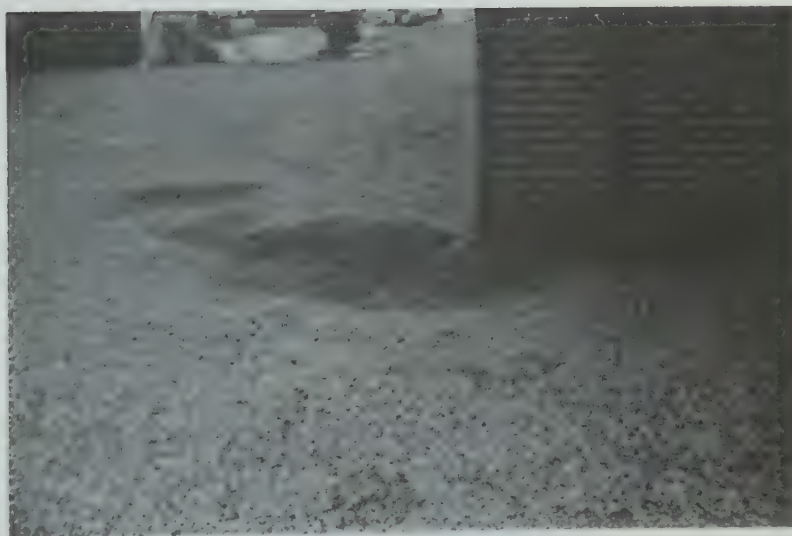
39. Asphalt exposed when gravel blown away.

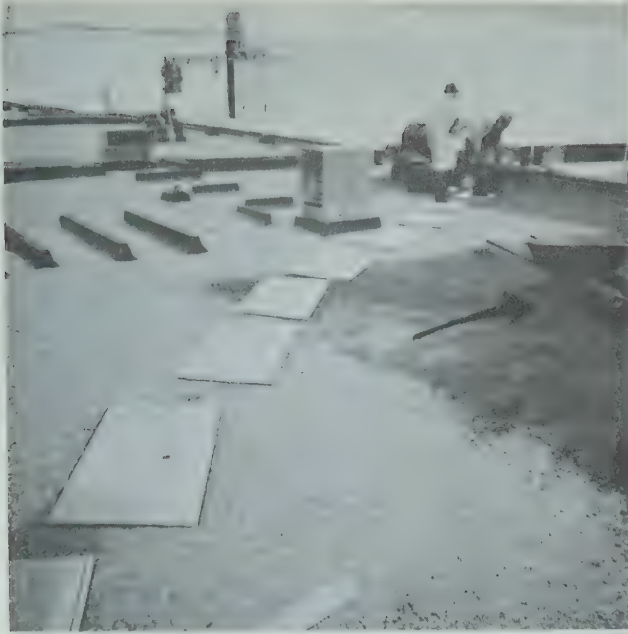
40. Finished membrane protected, however, unless wheelbarrow is handled with care, membrane could be ripped.

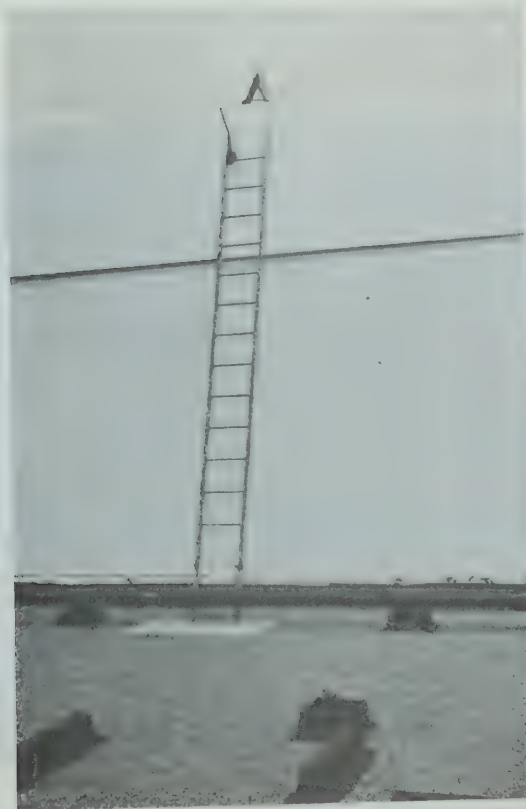
- 40A Proper protection for ladder feet - very often overlooked.

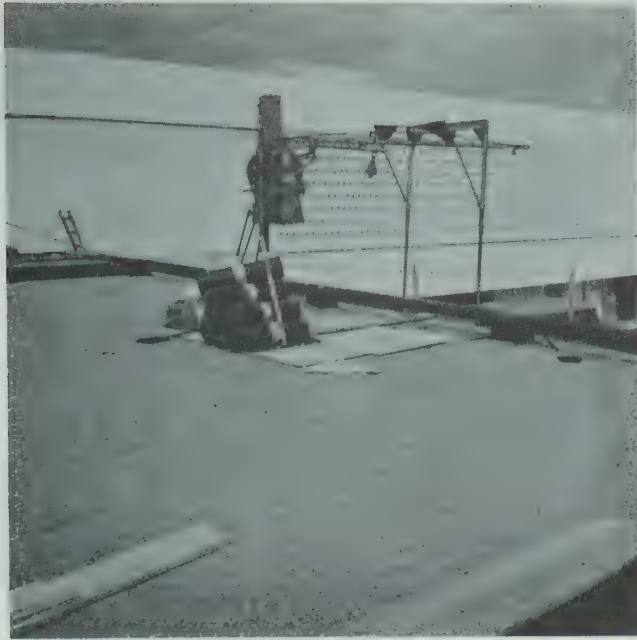
41. Protection of membrane at materials handling area.

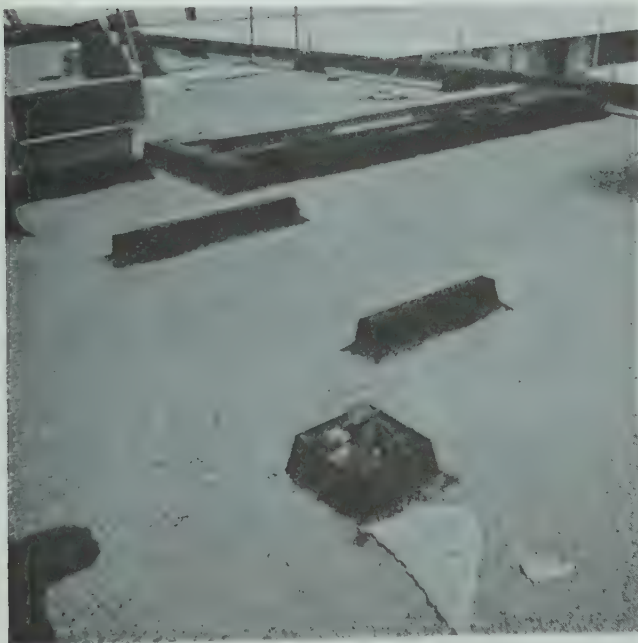
42. Curbs readied for flashing.

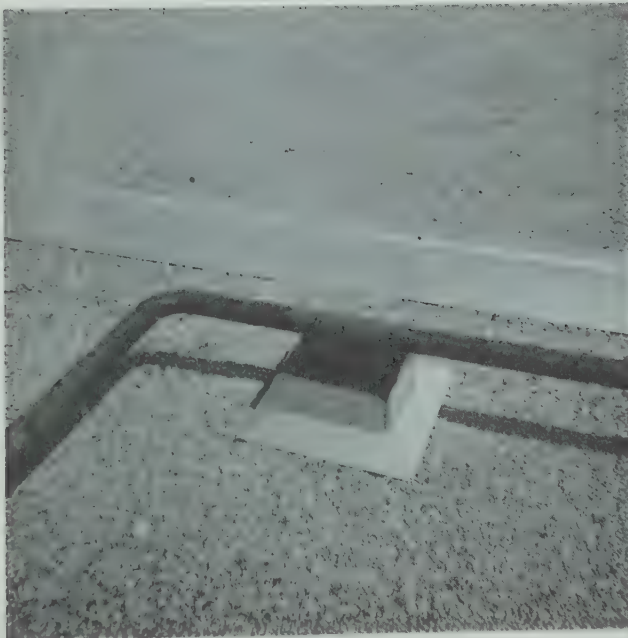
44. Gumpot installation properly installed around pipe anchor.

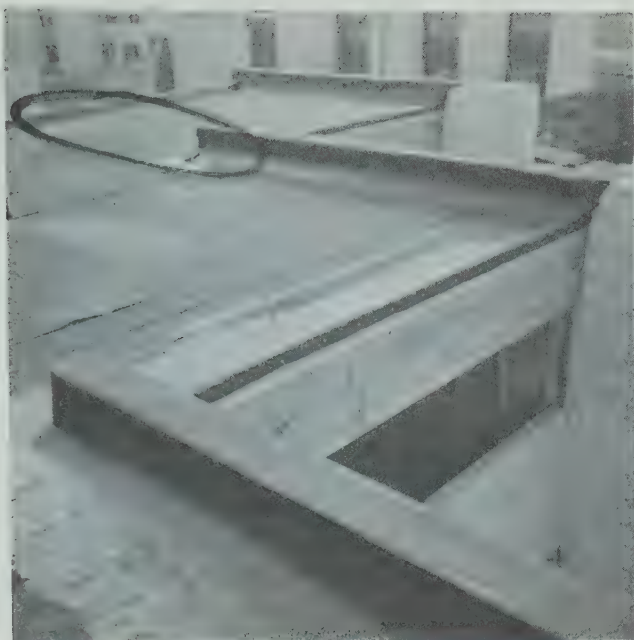
45. Proper return of felt over fascia, however, note lack of control joints in membrane at changes of roof direction.

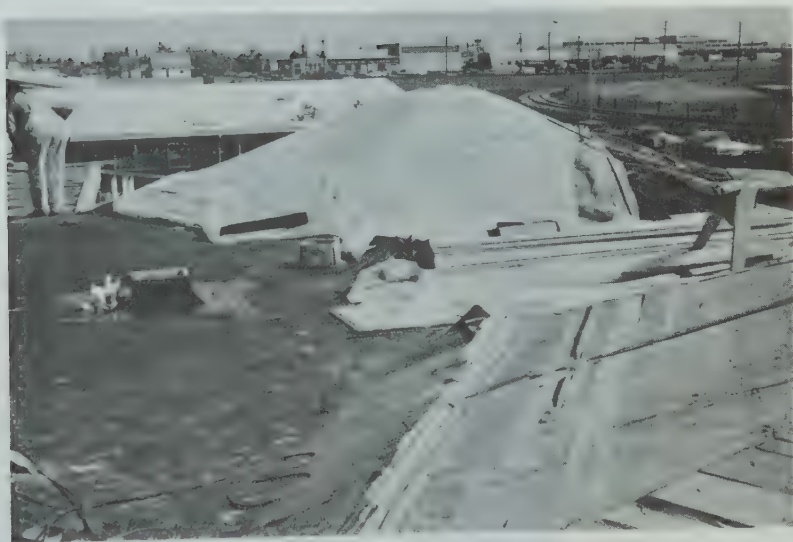
46. Proper protection of wood deck awaiting application of roofing.

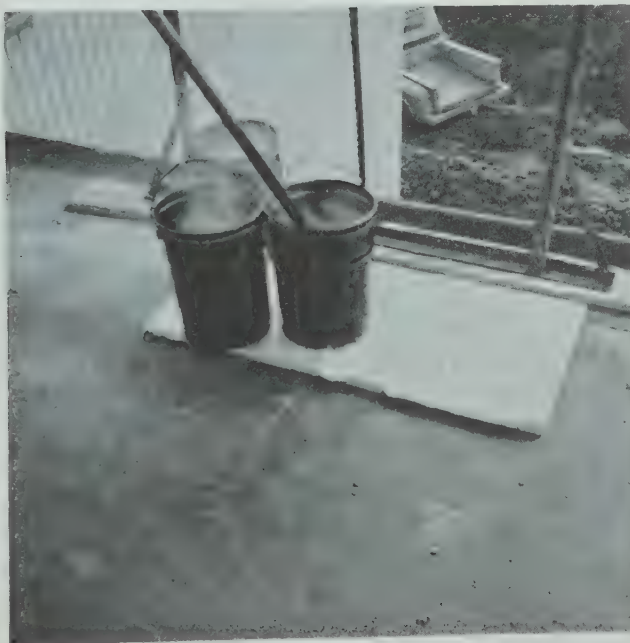
48. Roof-mate does not melt under bucket of asphalt at 400° F. Rings are asphalt drip.

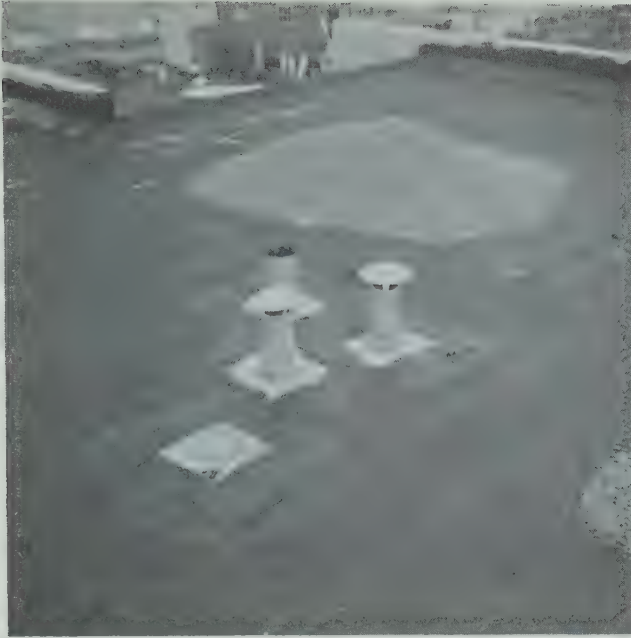
49. Gravel should not be stored on roof, but should be raised to roof only as required.

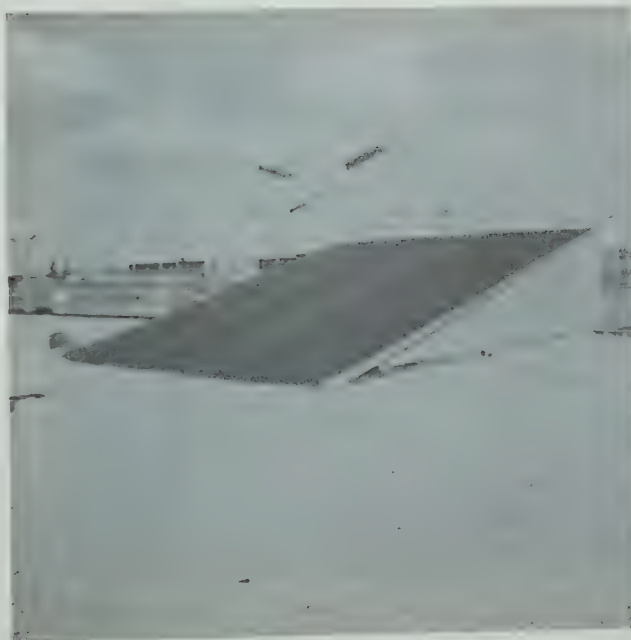
50. Application of 60# N.I.S. ( 19 inch selvege, mineral surfaced). Better to apply in direction of slope than to apply horizontally. Horizontal application usually results in "waving".

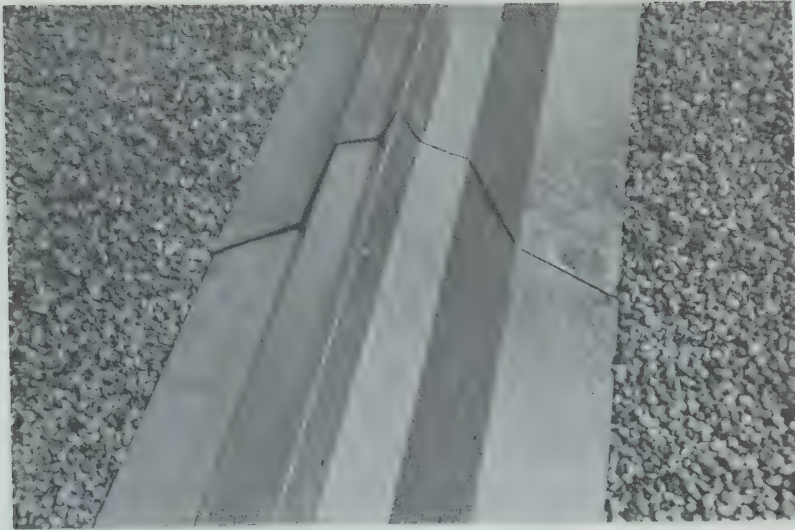
55. Good flashing detail - note absence of exterior caulking, and slope of top surface.

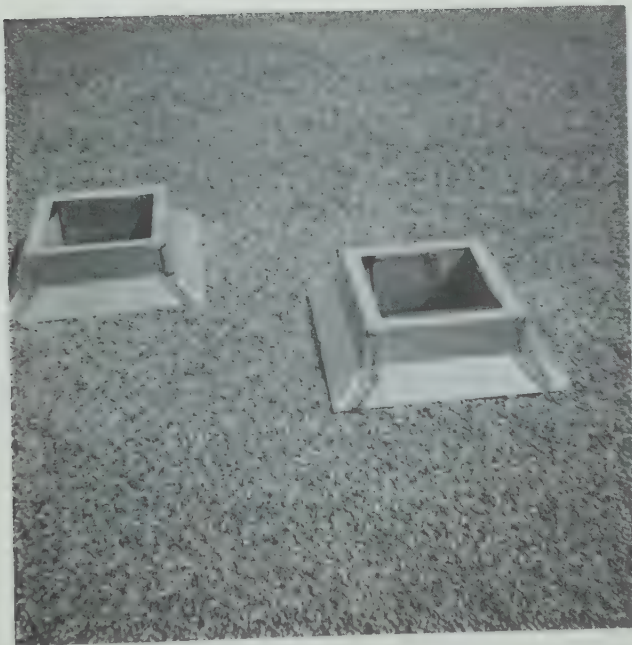
56. Flashings properly kept free of membrane.

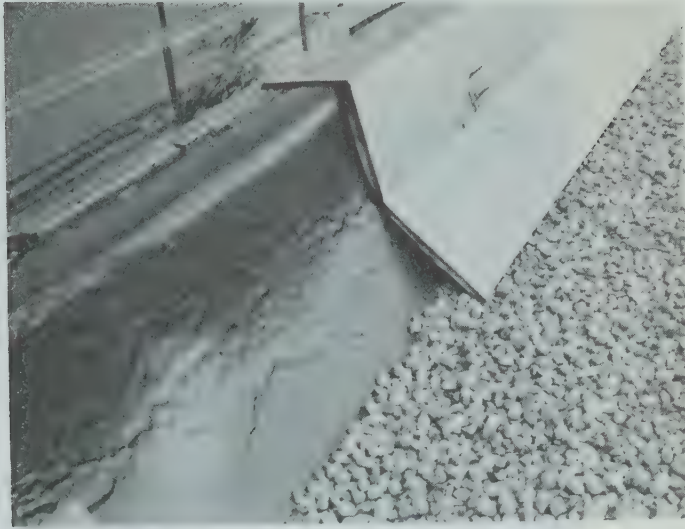
56A Note gravel run under flashing - proper installation.

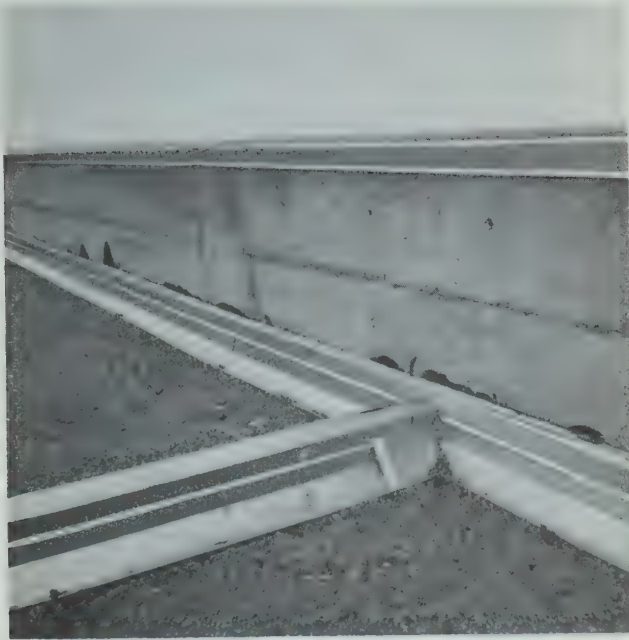
58. Note 10" high control joint - this detail should be no less than 10" in height. Note also exposed face of parapet wall - this wall should be protected.

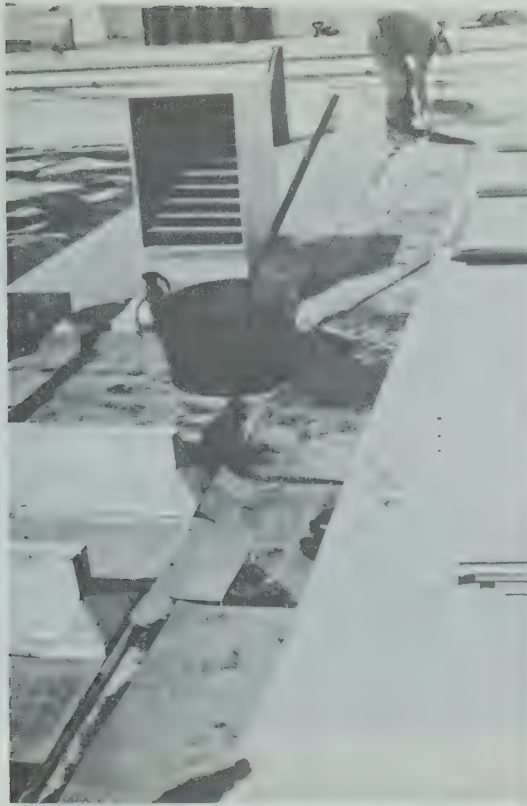
60. Installing base sheet vapour barrier over conduit - unsatisfactory application, and open invitation to trouble. (Roofer has no choice here - only the designer could alter this situation).

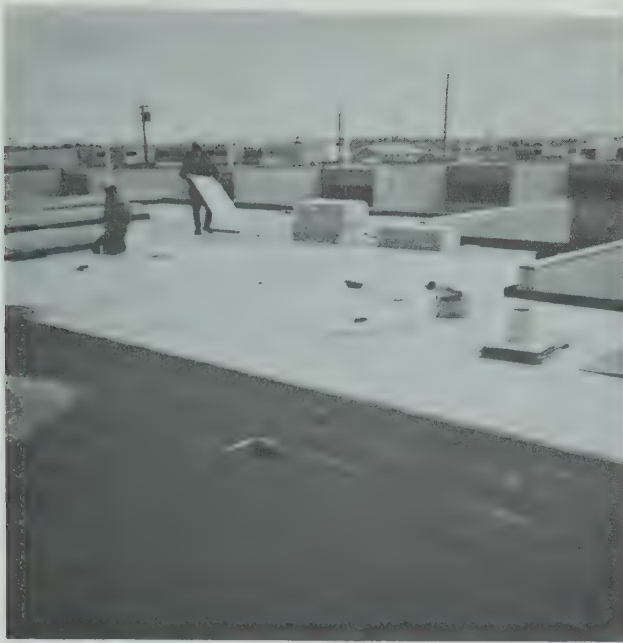
62. Application of Roof-Mate foamed compressed polystyrene rigid insulation directly to wood deck.

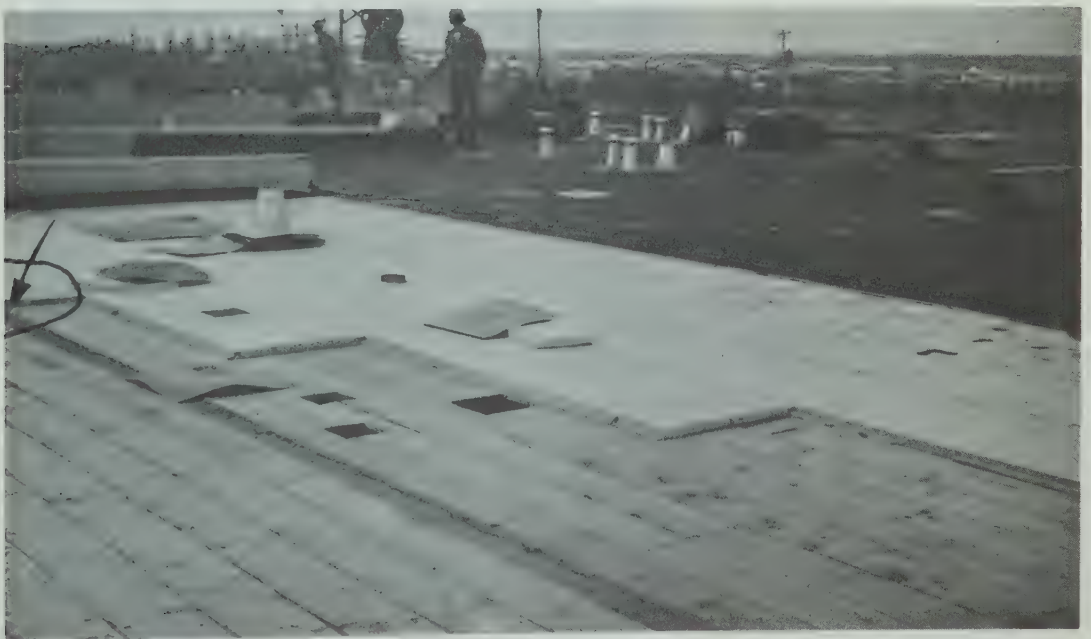
63.  $1\frac{1}{4}$ " Roof-mate being nailed to  $\frac{3}{4}$ " wood deck - 8 roofing nails per sheet. Note discontinuity of roof deck and uneven top of concrete wall. No joint in the roofing was provided here. No vapour barrier used, according to Roof-Mate specifications.

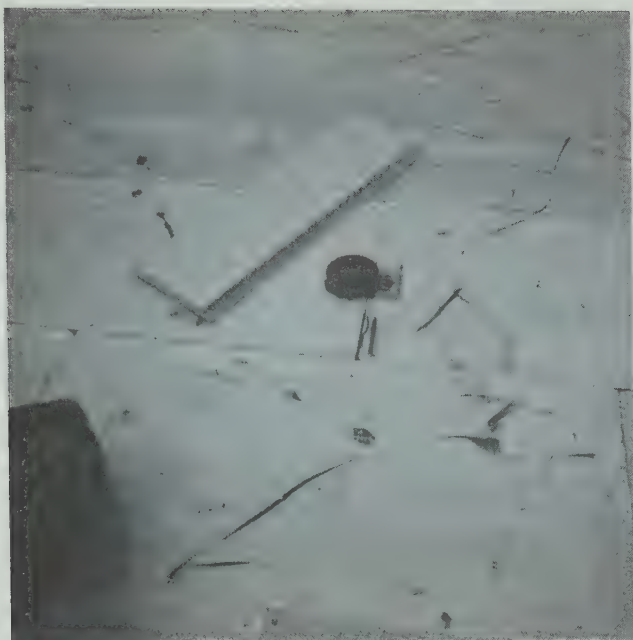
64. Joints in insulation exceed  $\frac{1}{4}$ " in width - note pencil as reference.

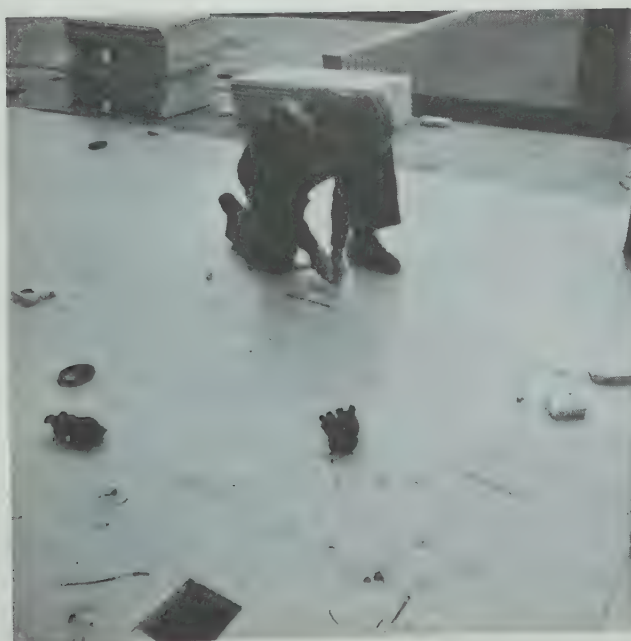
65. Joints being plugged - up until membrane was ready for application. Joints not plugged by then, were left.

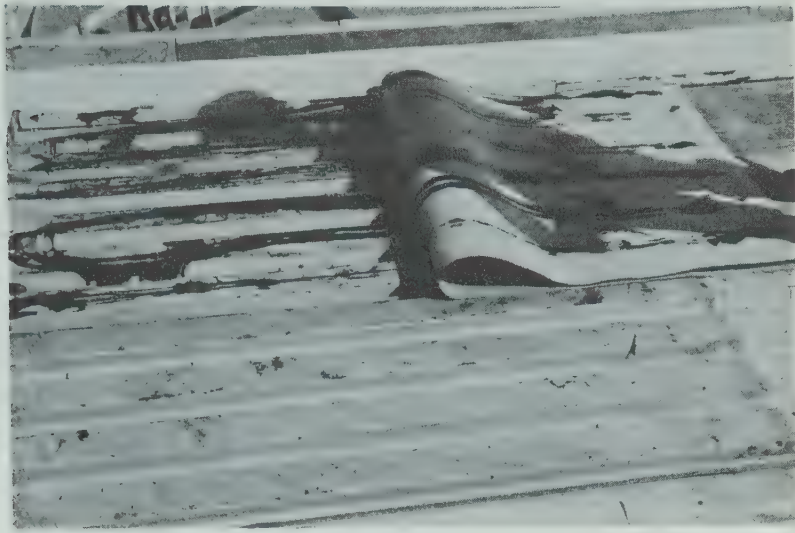
71. Cold adhesive applied, and 30# glass base sheet placed.

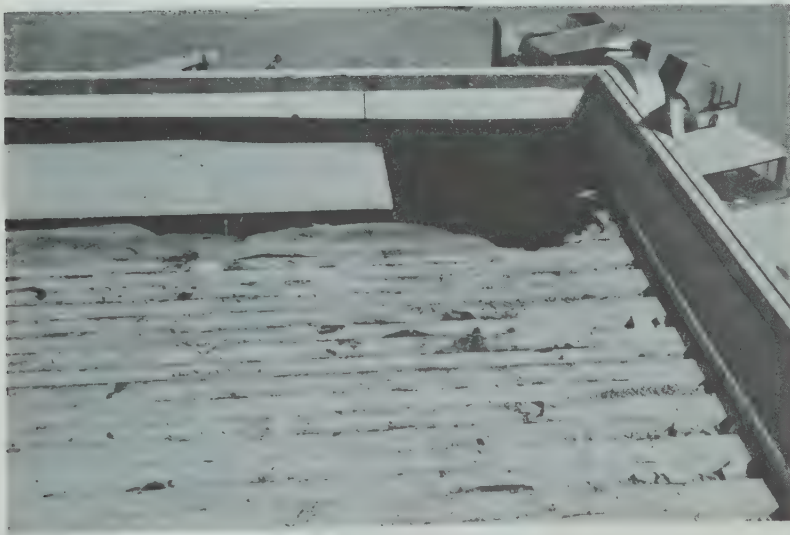
76. Insulation ready for turning back of edge cutoff.

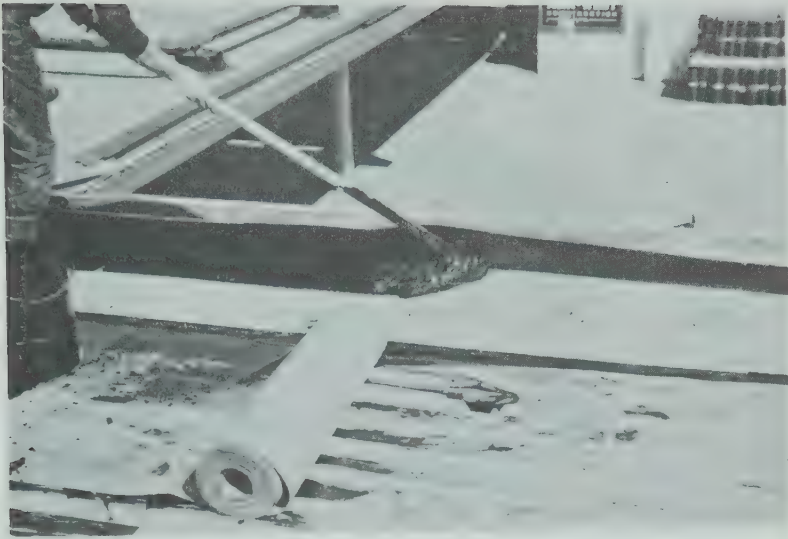
77. Mopping to seal edge cutoff.
